HEAT EXCHANGER FOULING AND CLEANING EXPERIENCE
IN ONTARIO HYDRO'S NUCLEAR GENERATION DIVISION

Prepared by: J.G. Roberts
Bruce NGS-B

Date: June 1981

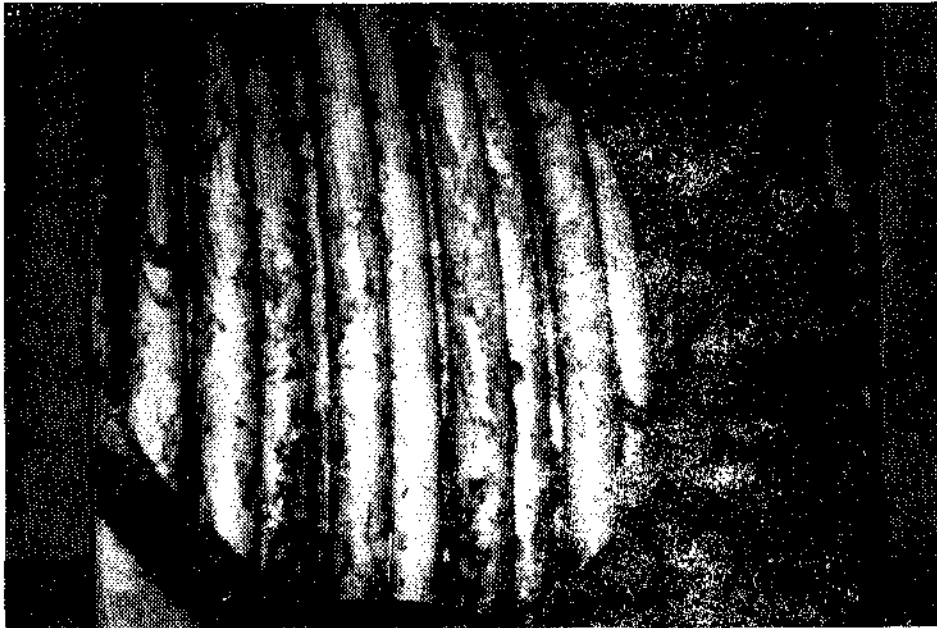
Irradiated Fuel Storage Bay Heat Exchanger
After Chemical Cleaning

Figure 4 shows another fouled heat exchanger, the PNGS-A Irradiated Fuel Bay Heat Exchanger, and Figure 5 shows the same heat exchanger after cleaning with inhibited formic acid.

The duration of the cleaning was five days, and cost \$9,000. Had we been able to use high pressure water jetting, this heat exchanger could have been cleaned for a third of the cost, and in one third of the time.
