CHAPTER 14  
B. MATERIALS IN THERMALHYDRAULICS LOOP OF CANDU REACTORS  
R.G. Fleck  
Ontario Hydro Research Division

Key issues related to the performance of components in the primary heat transport system of CANDU reactors are presented. A brief description is provided of the rationale for the selection of materials for specific components. Irradiation enhanced deformation of pressure tubes and calandria tubes is described along with an outline of the deformation mechanisms and the important metallurgical parameters. The factors which resulted in pressure tube leaks in Pickering and Bruce reactors are discussed and a brief description of the delayed hydride cracking mechanism is provided. Fuel bundle performance has been satisfactory; however potential failure of cladding could occur by stress corrosion cracking and this is discussed. The performance of steam generator tubing is presented and possible failure mechanisms are outlined.

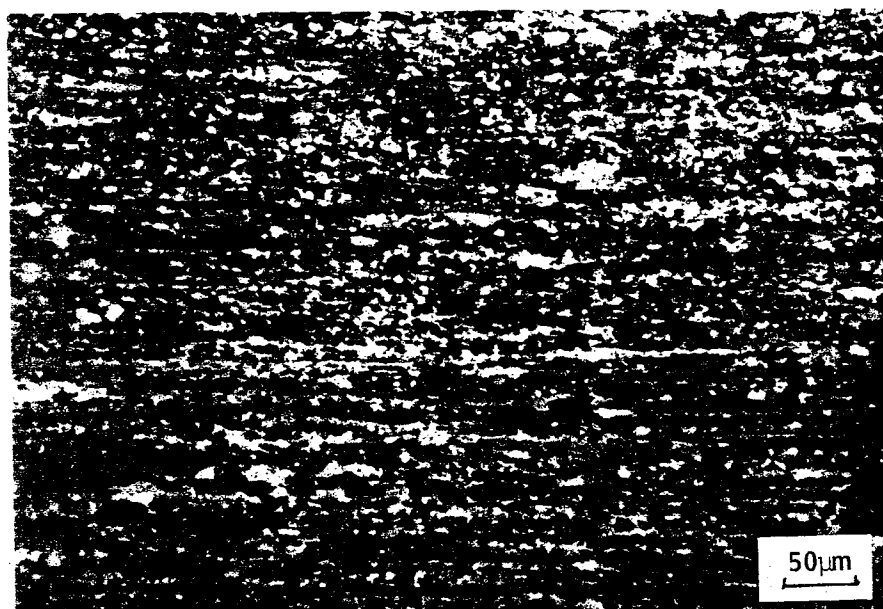
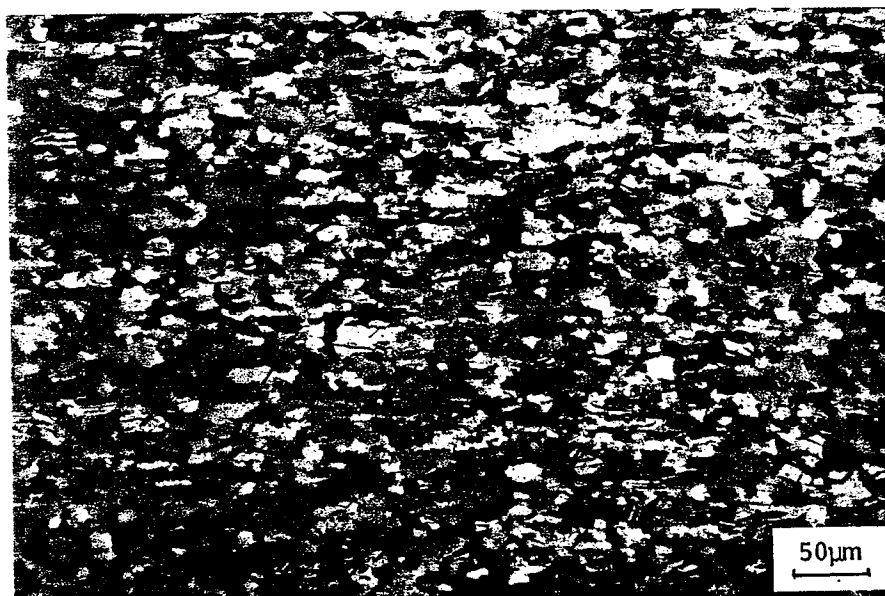
FIGURE 7  
OPTICAL MICROGRAPHS OF LONGITUDINAL SECTIONS  
FROM ZIRCALOY PRESSURE TUBES

PICKERING 2 - FAST ELONGATING TUBE

PICKERING 2 - SLOW ELONGATING TUBE

- c) Grain Shape - the elongation characteristics of the Zircaloy pressure tubes in PGSA Units 1 and 2 are different than those of the Zr-2.5 wt% Nb tubes in Units 3 and 4. The average elongation rates are the same but the tube-to-tube variation is much greater in Units 1 and 2 than in Units 3 and 4. Examination of material from "fast" and "slow" elongating Zircaloy tubes indicated a difference in grain shape. The "fast" tubes had highly elongated grains (Figure 7), whereas the slow tubes tended to have an equiaxed grain shape/2/. Theoretically, the grain shape is expected to influence the irradiation growth component - elongated grains in effect increase the extent of anisotropic deformation in the pressure tubes. For Zr-2.5 wt% Nb pressure tubes the grain shape is one of highly elongated grains (Figure 8) and to change the grain shape a post-extrusion anneal would have to be implemented. Consequently, the grain shape of Zr-2.5 wt% Nb tubes is consistently one which promotes irradiation growth in the axial direction of the tube.
